2015 - 2018 Cadillac CTS-V: GM TechLink: Hard Shifting into 1st Gear or Reverse

2015 - 2018 Cadillac CTS-V: Hard Shifting into 1st Gear or Reverse

GM TechLink June 10, 2017

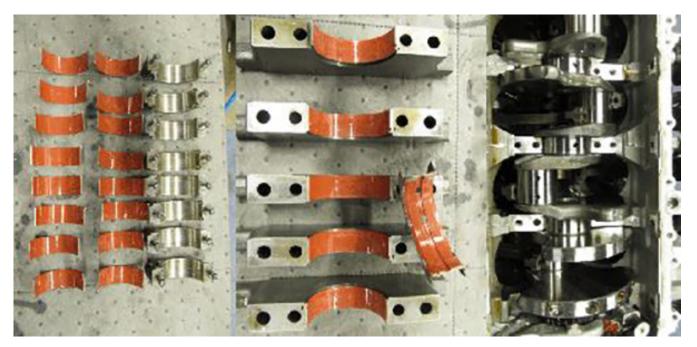
Fig. 10

The hard shifting conditions may require replacement of the crankshaft or thrust bearing. Before replacing any components, check for excessive crankshaft end play. Crankshaft end play clearance should be within a specification of 0.0015–0.0086 in. (0.040–0.220 mm).

If end play is found to be out of specification, remove the engine and check for possible crankshaft thrust bearing or crankshaft wear. The crankshaft and bearings should not show signs of excessive wear. (Fig. 10) Inspect the thrust bearing for wear on one side and the crankshaft on the mating surface.

If wear is evident — the three vertical channels may be worn off — replace the connecting rods, main bearings, thrust bearing and crankshaft.
