# 2016 - 2019 Cadillac CTS-V: GM TechLink: Low Oil Pressure Conditions

**GM TechLink**

**September 13, 2019**

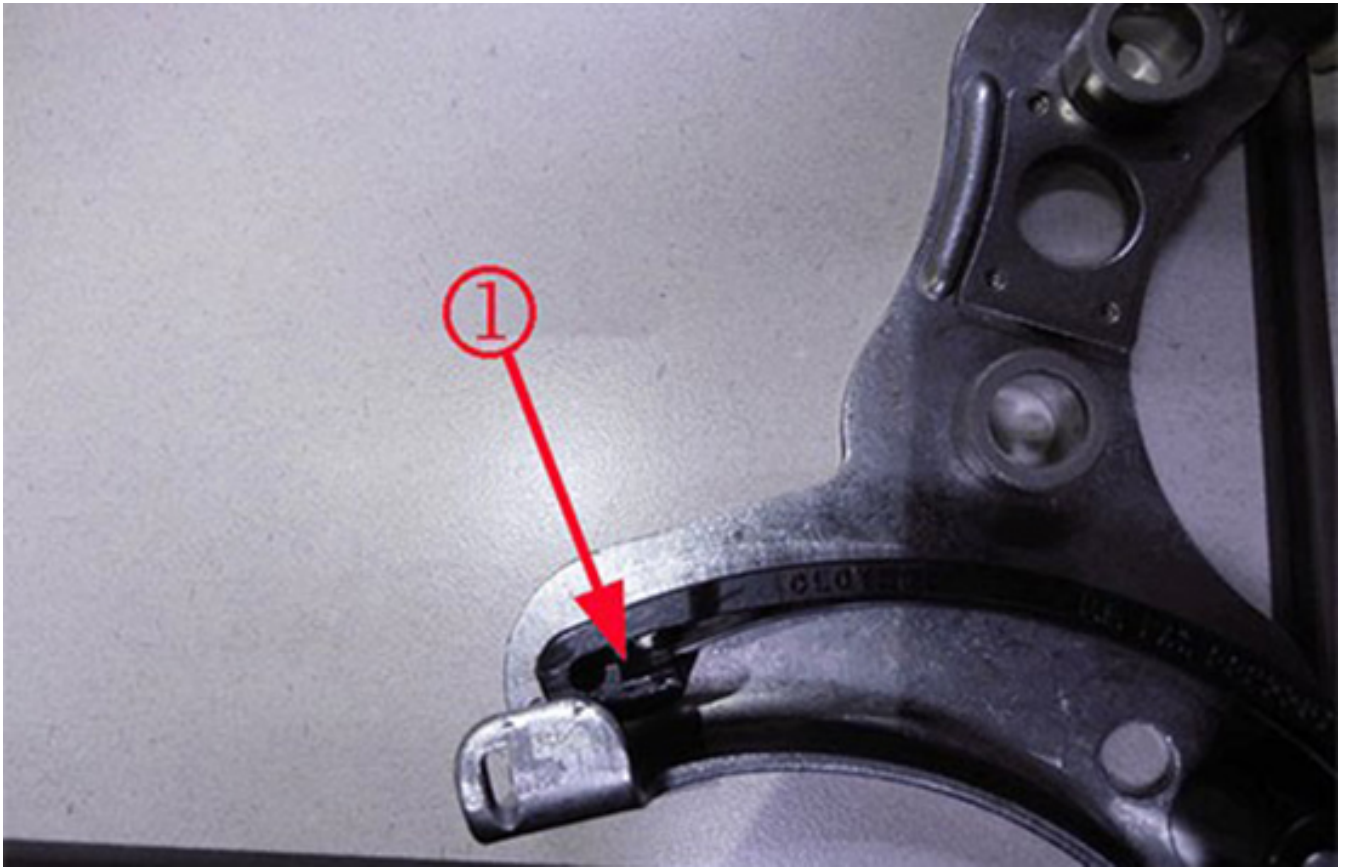
**Fig. 19**

If these conditions are found, the tensioner spring in the timing chain guide may be "short" and not fully seated into the guide pivot end. (Fig. 19) Cycling the oil pump control valve will not cause any changes in the oil pump response. Replace the timing chain tensioner guide.

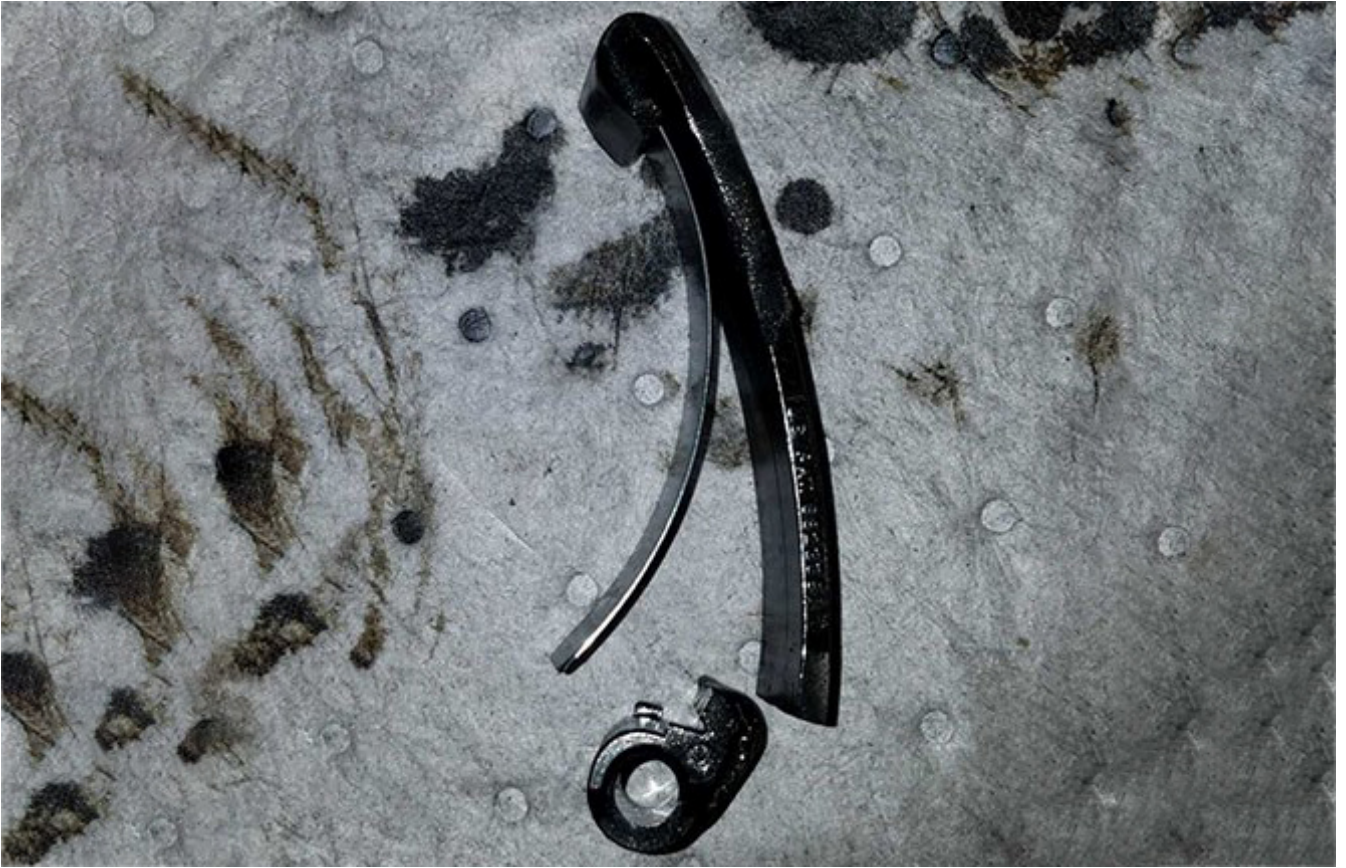
**Fig. 20**

In addition, a broken tensioner shoe (Fig. 20) may allow the spring to rub a hole in the oil pump.
