# **2016 - 2019 Cadillac CTS-V: GM TechLink: Coolant Entering Engine Cylinders**

**GM TechLink**

**May 17, 2019**

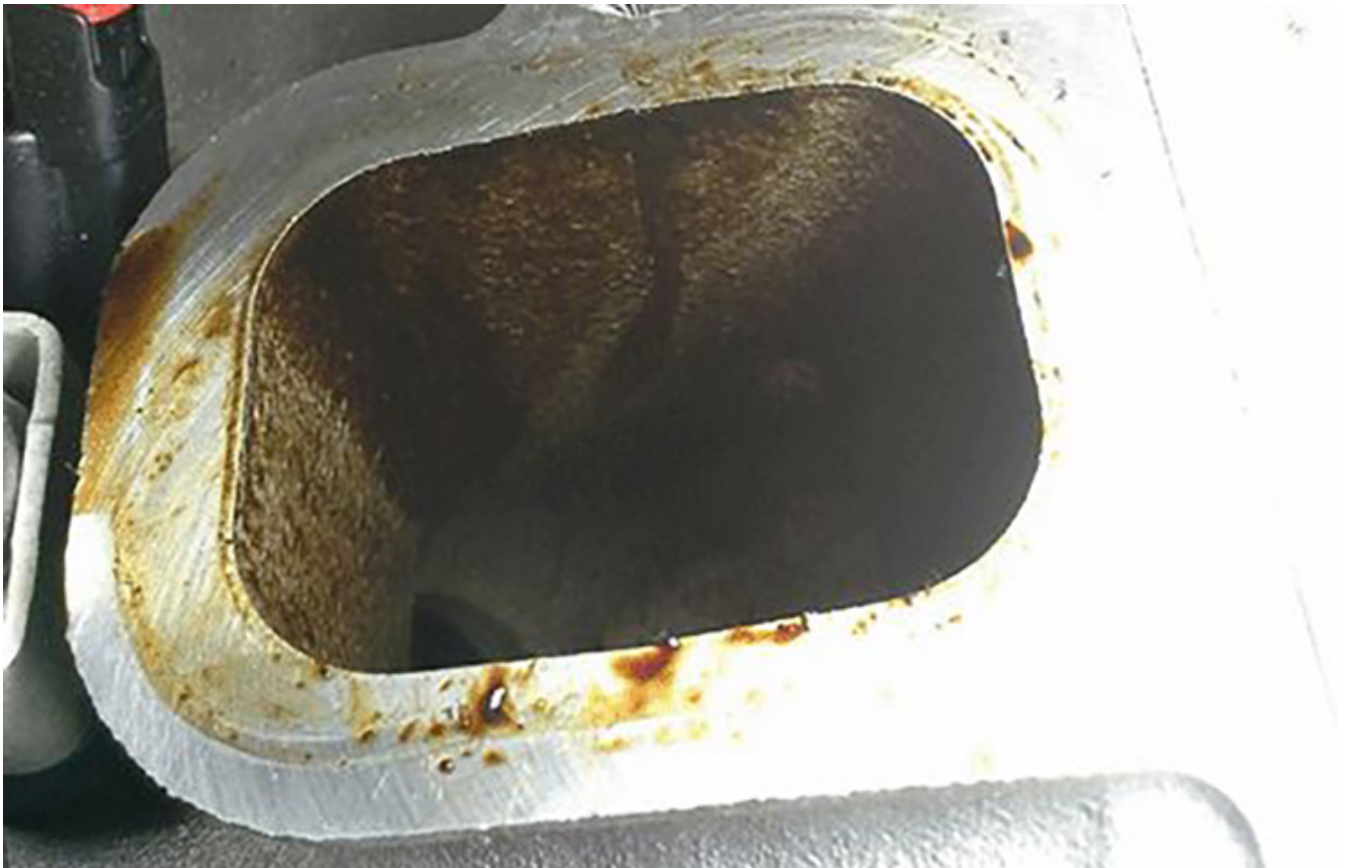
**Fig. 13**

If the head casting line is the issue, the intake port will be wet with a coolant and oil mix. This condition may cause the running rough while warm concern with or without DTCs set. The location where the coolant is running down in the port will look washed down. If this condition is found, the cylinder head will need to be replaced. (Fig. 13)
