## 2015 - 2018 Cadillac CTS-V: GM TechLink: Hard Shifting into 1st Gear or Reverse

GM TechLink June 10, 2017

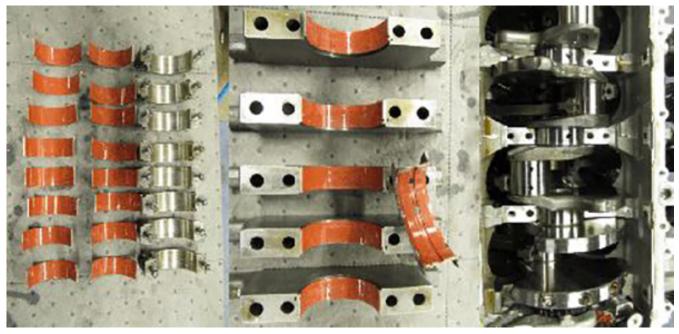
#### **Fig. 10**

The hard shifting conditions may require replacement of the crankshaft or thrust bearing. Before replacing any components, check for excessive crankshaft end play. Crankshaft end play clearance should be within a specification of 0.0015–0.0086 in. (0.040–0.220 mm).

If end play is found to be out of specification, remove the engine and check for possible crankshaft thrust bearing or crankshaft wear. The crankshaft and bearings should not show signs of excessive wear. (Fig. 10) Inspect the thrust bearing for wear on one side and the crankshaft on the mating surface.

If wear is evident — the three vertical channels may be worn off — replace the connecting rods, main bearings, thrust bearing and crankshaft.
