# 2018 - 2019 Cadillac ATS-V - CTS-V: Service Bulletin: #20-NA-054: Rear View Camera Guidance Lines Dim After Radio Replacement or Programming

## #20-NA-054: Rear View Camera Guidance Lines Dim After Radio Replacement or Programming - (Mar 3, 2020)

**Subject:** Rear View Camera  
Guidance Lines Dim  
After Radio Replacement  
or Programming

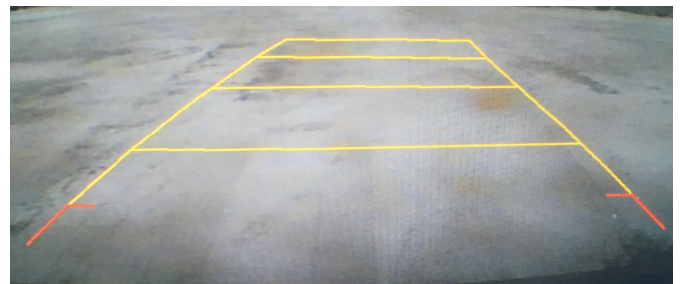
**Original design:**

Some customers, after having radio  
replacement or radio reprogramming,  
may report that the Rear-View Camera  
(RVC) guidance lines are not as bold

as previously viewed, that they are faint, see-through, thinner, dim, or translucent; and they used to be more visible. A comparison between similar vehicle models may, or may not, show a difference in rear view camera guidance line appearance.

Do not attempt repairs. The thinner, lighter appearance of RVC guidance lines is operating to design intent.
