2018 - 2019 Cadillac ATS-V - CTS-V: Service Bulletin: #20-NA-054: Rear View Camera Guidance Lines Dim After Radio Replacement or Programming

#20-NA-054: Rear View Camera Guidance Lines Dim After Radio Replacement or Programming - (Mar 3, 2020)

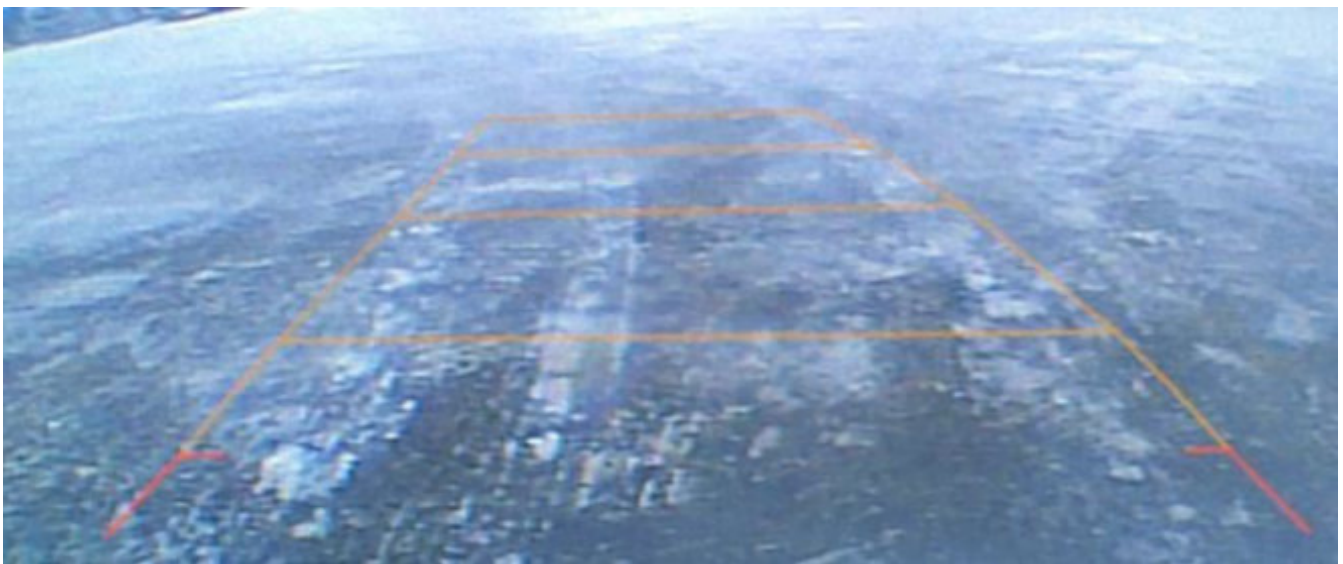
New design:

This may be caused by installing calibration files released in mid-2018 during radio replacement or reprogramming of the radio. The change to increase translucency was done to prevent the lines from

obstructing objects in the field-of-view.

Do not attempt repairs. The thinner, lighter appearance of RVC guidance lines is operating to design intent.
