**2016 - 2019 Cadillac CTS-V: Service Bulletin:  
#15-06-01-002K: Engine Misfire/Tick Noise,  
Malfunction Indicator Lamp (MIL) Illuminated -  
DTC P0300 Set - (Dec 17, 2020)**

**Subject:** Engine Misfire/Tick Noise,  
Malfunction Indicator Lamp (MIL)  
Illuminated - DTC P0300 Set

Equipped with 5.3L Engine (RPOs L83, L8B) or 6.2L Engine (RPOs L86, LT1, LT4)

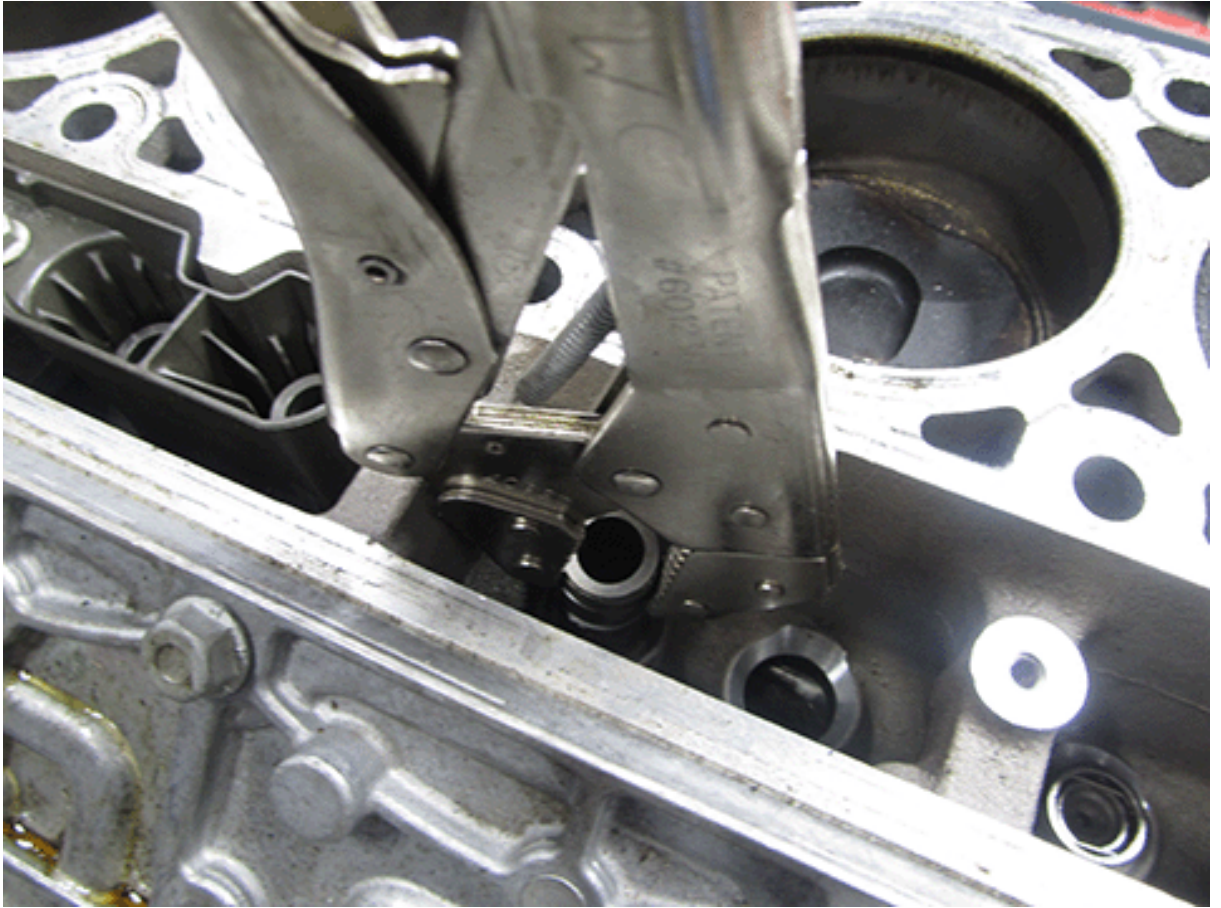
There are two approved processes for removing the lifter when stuck in the bore.

1. Use vice grips with a slide hammer.

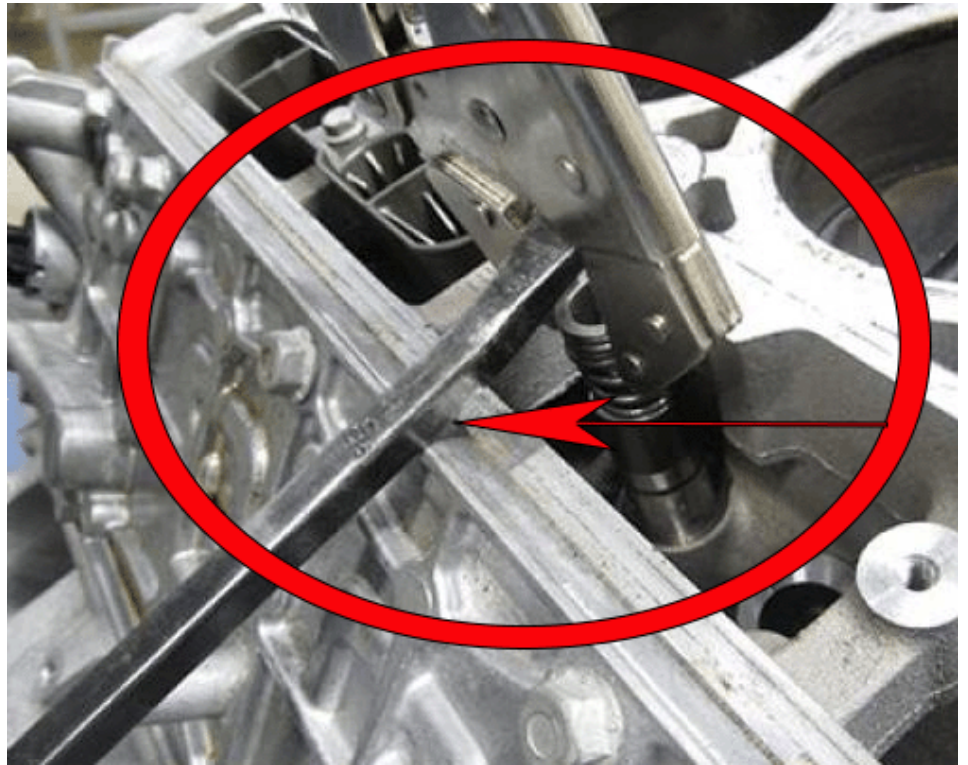
**Note:** Be sure *NOT* to pry on the sealing surface of the block, as shown in the illustration above.

1. Use vice grips with a small pry bar.
