2014 - 2019 Cadillac ATS-V - CTS V-Sport: Service Bulletin: #19-NA-256: Diagnostic Tips for Knocking, Rattle, Squeak and/or Squeal Type Noise from Engine

#19-NA-256: Diagnostic Tips for Knocking, Rattle, Squeak and/or Squeal Type Noise from Engine - Engine Replacement Recommendations for HFV6 Gen 1 and Gen 2 - (Jan 14, 2021)

Subject: Diagnostic Tips for Knocking, Rattle, Squeak and/or Squeal Type Noise from Engine – Engine Replacement Recommendations for HFV6 Gen 1 and Gen 2

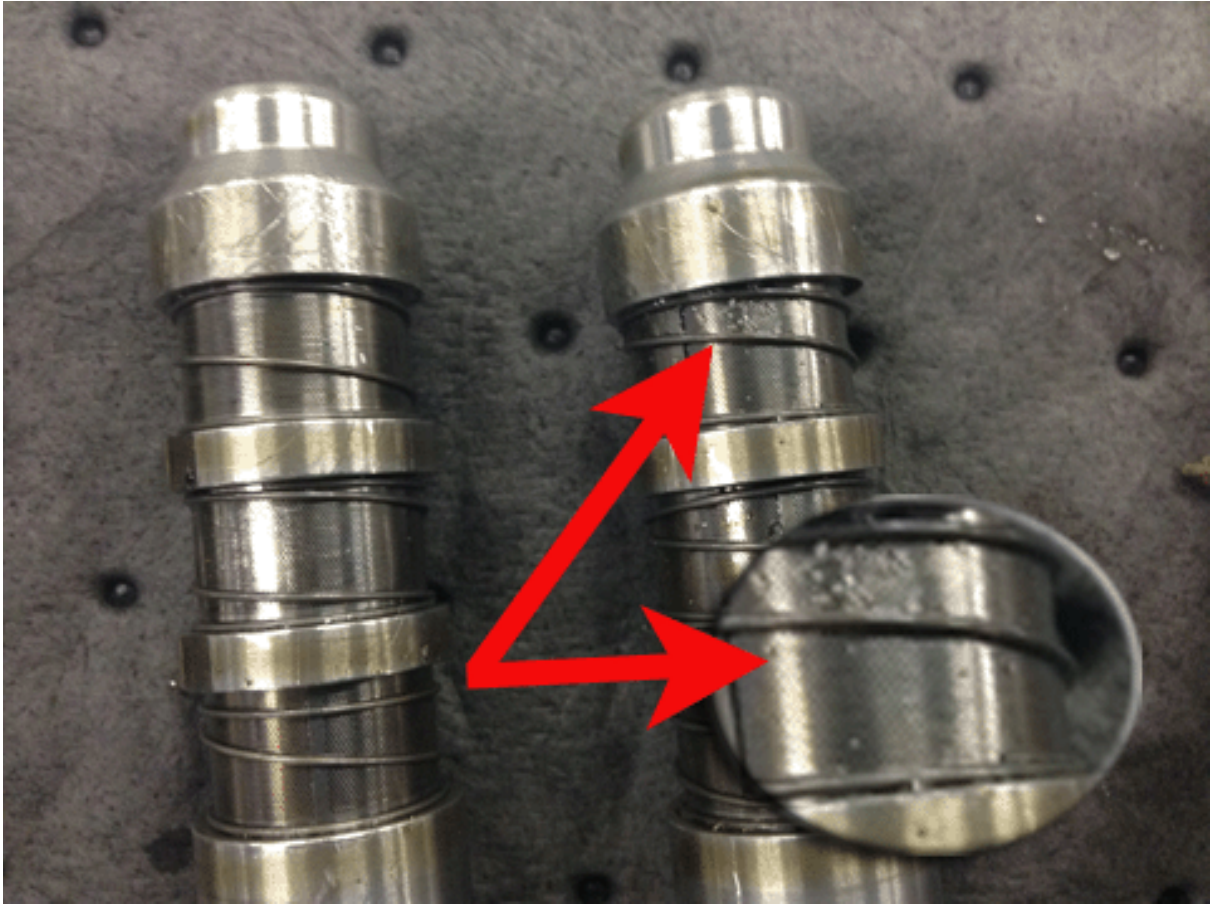
1. Inspect the oil control solenoids for metal debris. This shows the oil filter is in by-pass and unfiltered oil with bearing debris was pumped into the oil lubrication galleys, throughout the engine.

Any of the above 3 instances would be cause to replace the engine instead of repair.
