**2016 - 2020 Cadillac ATS-V CTS-V CT6-V:
Service Bulletin: #PIP5785: Whining/Whirring,
Whistle, Squeaking, Groaning/Growling Noise
Coming From The Front Wheel/Engine Area -
(Mar 6, 2021)**

Subject: Whining/Whirring, Whistle,
Squeaking, Groaning/Growling Noise
Coming From The Front
Wheel/Engine Area

Brand:	Model:	Model Year:		VIN:		Engine:	Transm ission:
		from	to	from	to		
Cadillac	ATS	2017	2019	All	All	All	All
Cadillac	CTS	2017	2019	All	All	All	All
Cadillac	CT6	2016	2020	All	All	All	All

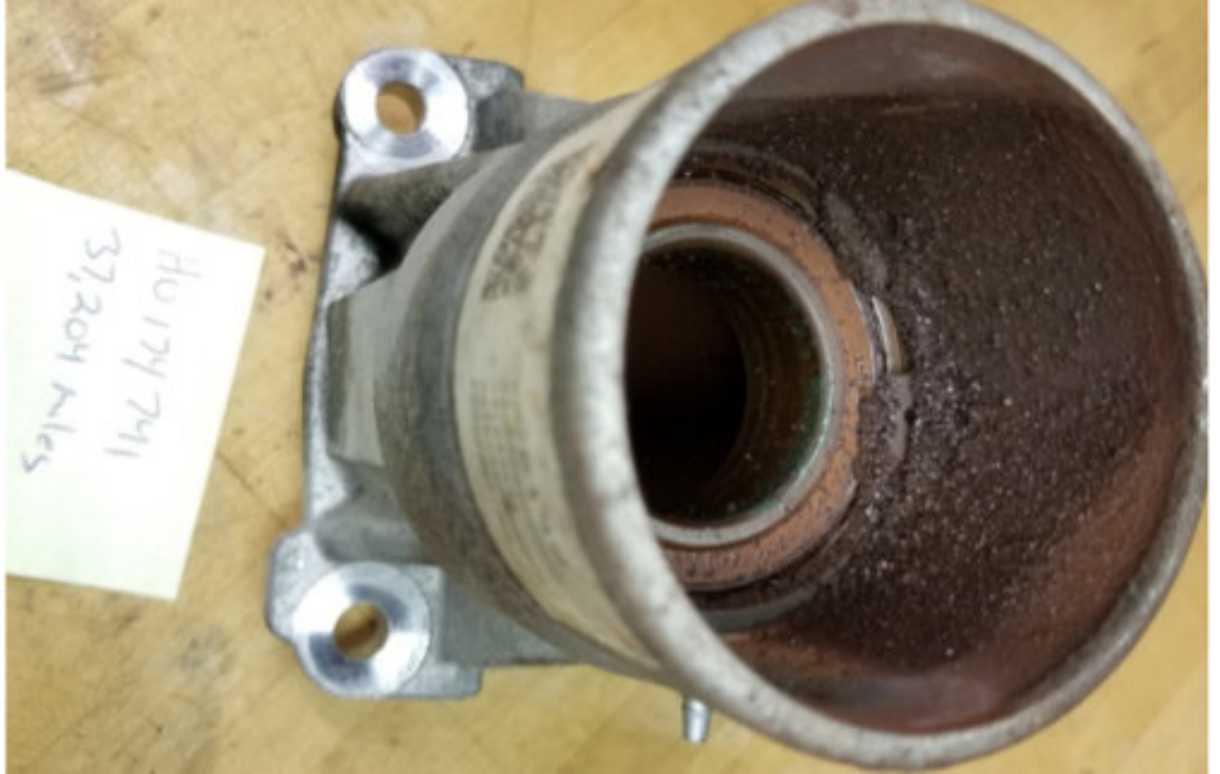
This condition may be caused by fretting between the Front Intermediate Shaft (IDS Shaft) and the Front Intermediate Shaft Bearing/Housing (IDS bearing). The fretting is the result of having a slip fit interface between the bearing and the IDS shaft, and combined with a bearing that has around 0.5Nm of torque to rotate (TTR).

1. Try and replicate the customer's complaint maneuver (generally the noise is heard while coasting and without brakes being applied)
2. Install Chassis Ears
3. Identify if the noise is at the Front Intermediate Shaft Housing
4. Once the noise is confirmed and isolated at the front intermediate shaft housing
5. Replace IDS Shaft and IDS Shaft Housing, refer to Front Wheel Drive Intermediate Shaft Replacement & Front Wheel

Drive Intermediate Shaft Housing Replacement in Si.
