2016 - 2020 Cadillac ATS-V CTS-V CT6-V: Service Bulletin: #PIP5785: Whining/Whirring, Whistle, Squeaking, Groaning/Growling Noise Coming From The Front Wheel/Engine Area - (Mar 6, 2021)

Subject: Whining/Whirring, Whistle,
Squeaking, Groaning/Growling Noise
Coming From The Front
Wheel/Engine Area

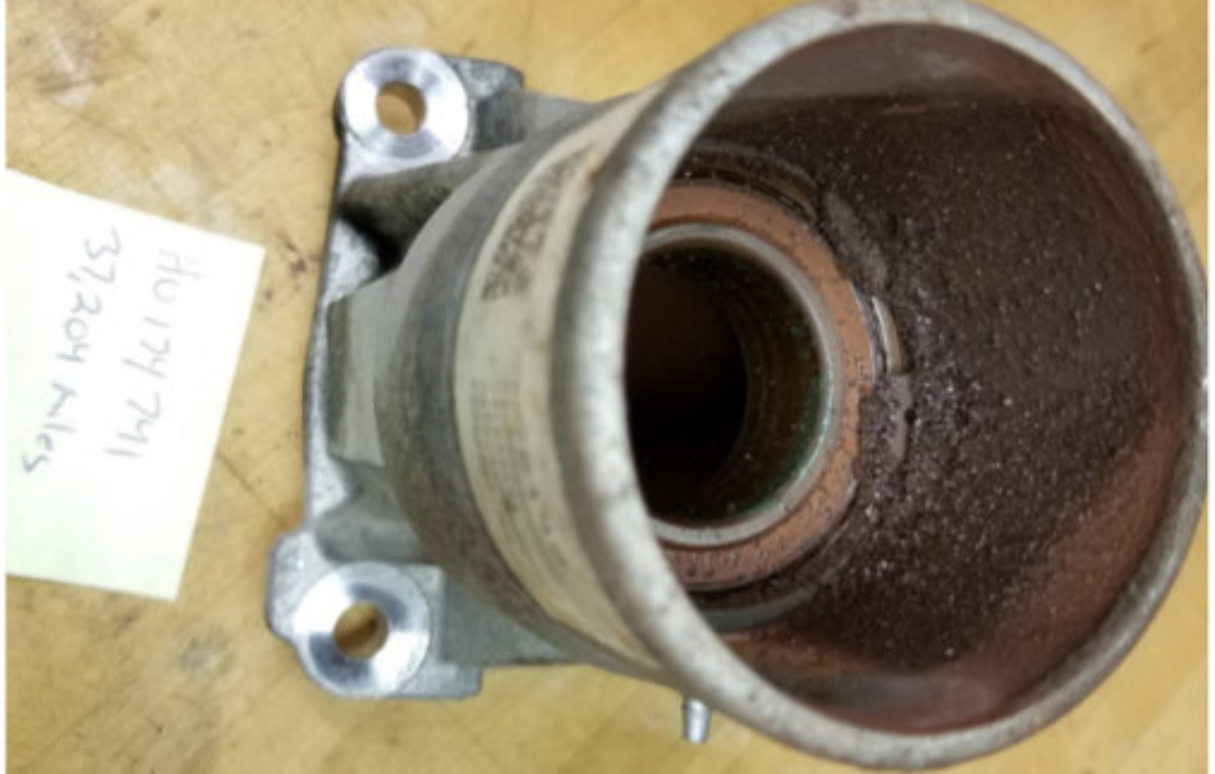
This condition may be caused by fretting between the Front Intermediate Shaft(IDS Shaft) and the Front Intermediate Shaft Bearing/Housing(IDS bearing). The fretting is the result of having a slip fit interface between the bearing and the IDS shaft, and combined with a bearing that has around 0.5Nm of torque to rotate(TTR).

1. Try and replicate the customers complaint maneuver (generally the noise is heard while coasting and without brakes being applied)
2. Install Chassis Ears
3. Identify if the noise is at the Front Intermediate Shaft Housing
4. Once the noise is confirmed and isolated at the front intermediate shaft housing
5. Replace IDS Shaft and IDS Shaft Housing, refer to Front Wheel Drive Intermediate Shaft Replacement & Front Wheel

Drive Intermediate Shaft Housing Replacement in Si.
