# 2016 - 2019 Cadillac CTS-V: GM TechLink: Engine Oil Overfill May Lead to Engine Vibration

**GM TechLink**  
**January 16, 2020**

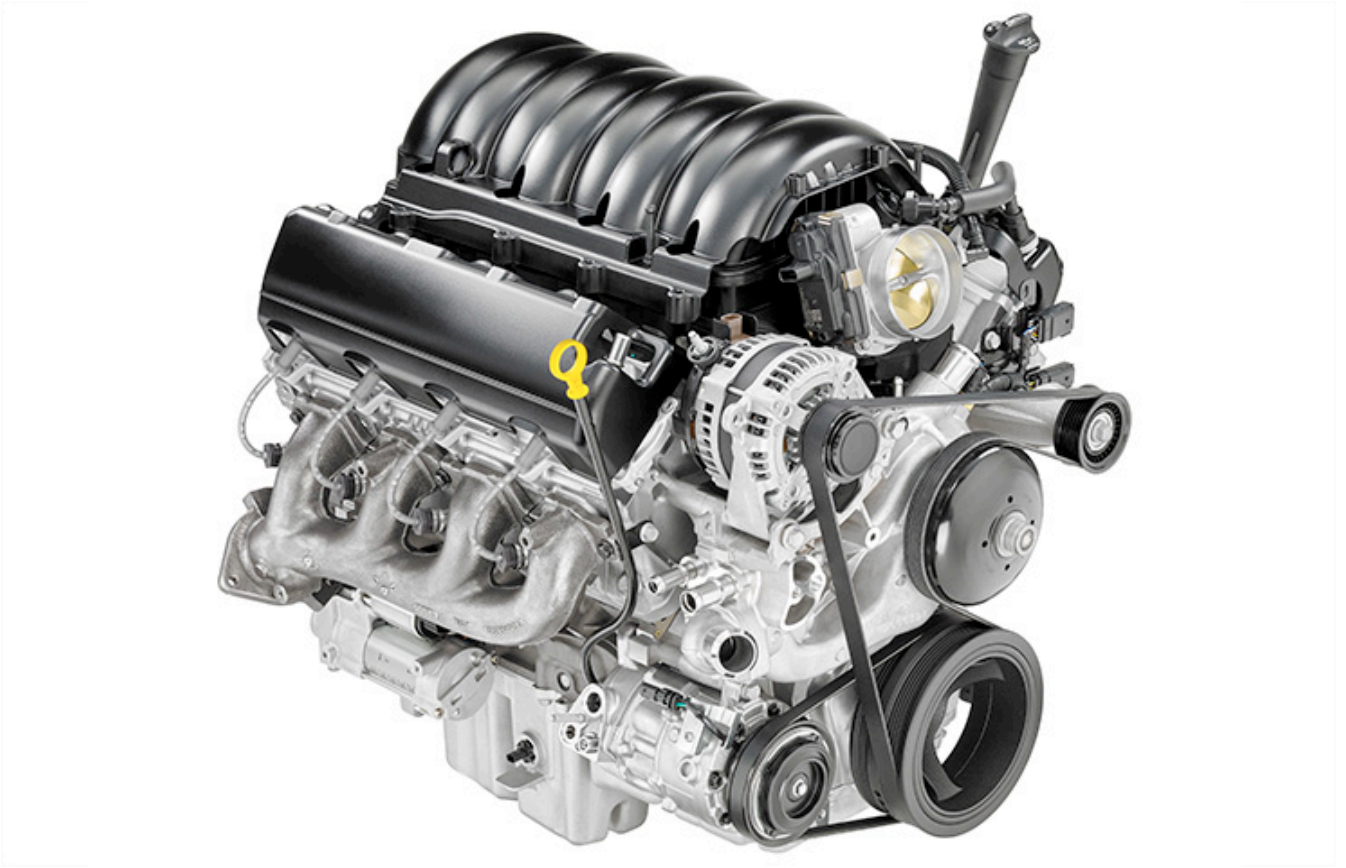
**Fig. 11**

The vibration may be due to an overfilled engine crankcase on the following engines: 4.3L V6 (RPO LV1, LV3); 5.3L V8 (RPO L82, L83, L84); 6.2L V8 (RPOs LT1, LT4, L86, L87). (Fig. 11) It may be found that the engine oil was recently changed.

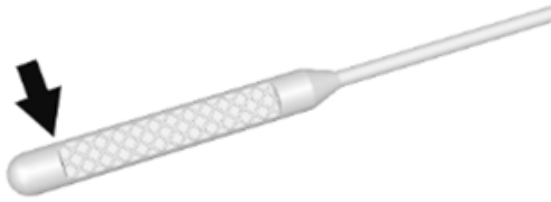
**Fig. 12**

If there is an engine vibration concern, check the engine oil level. Refer to the vehicle's Owner's Manual for details on correctly checking the engine oil level (Fig. 12) and the engine oil crankcase capacity.

If the engine was overfilled only with engine oil, adjust the oil level and check engine operation. It's possible that the engine was simply overfilled during an oil change or other maintenance service.

If the engine overfill was the result of contamination, diagnose the source of the contamination and make repairs as needed.
