## 2016 - 2019 Cadillac CTS-V: Service Bulletin: #PIP5212C: Concern Of An Engine Thermostat Tick Noise And/Or Running Hot - (Mar 30, 2021)

**Subject:** Concern Of An Engine Thermostat  
Tick Noise And/Or Running Hot

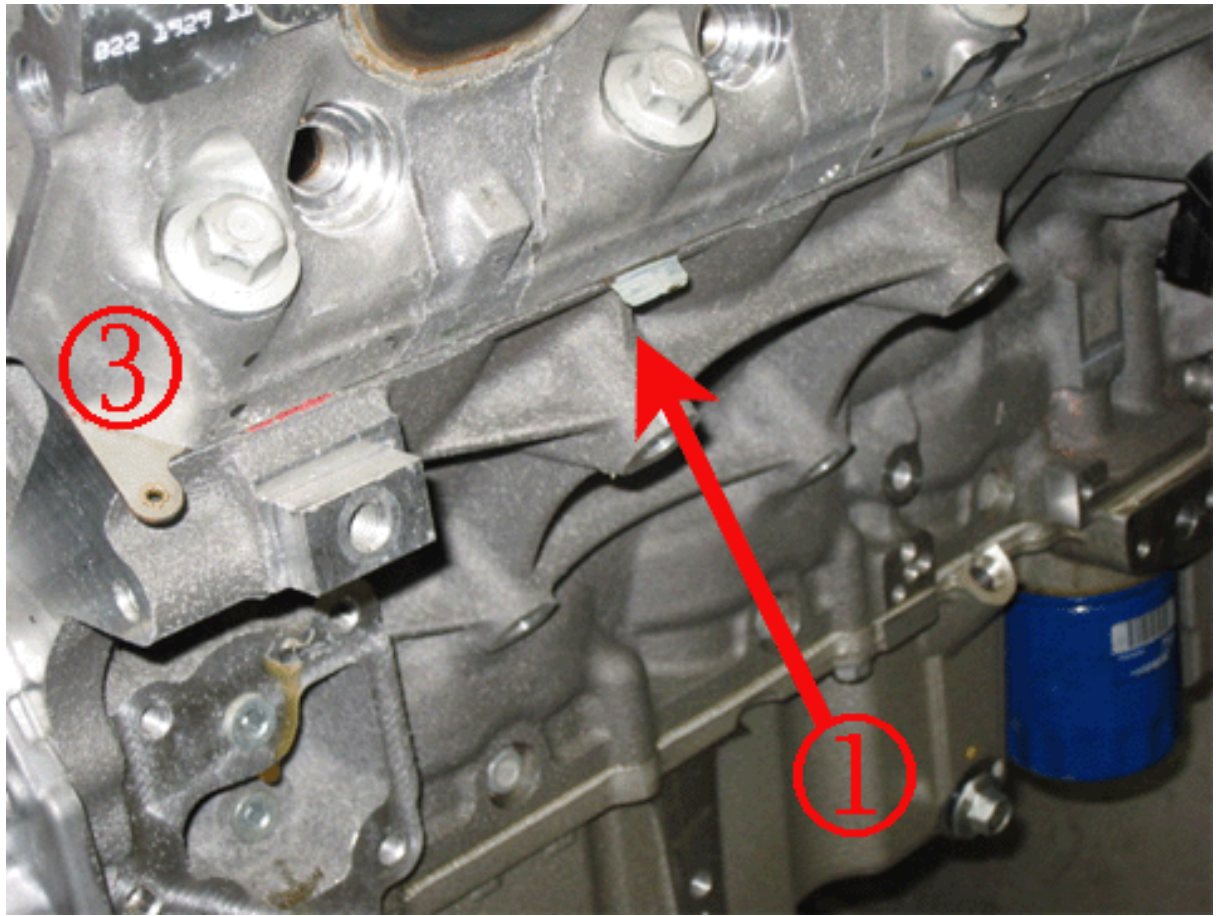
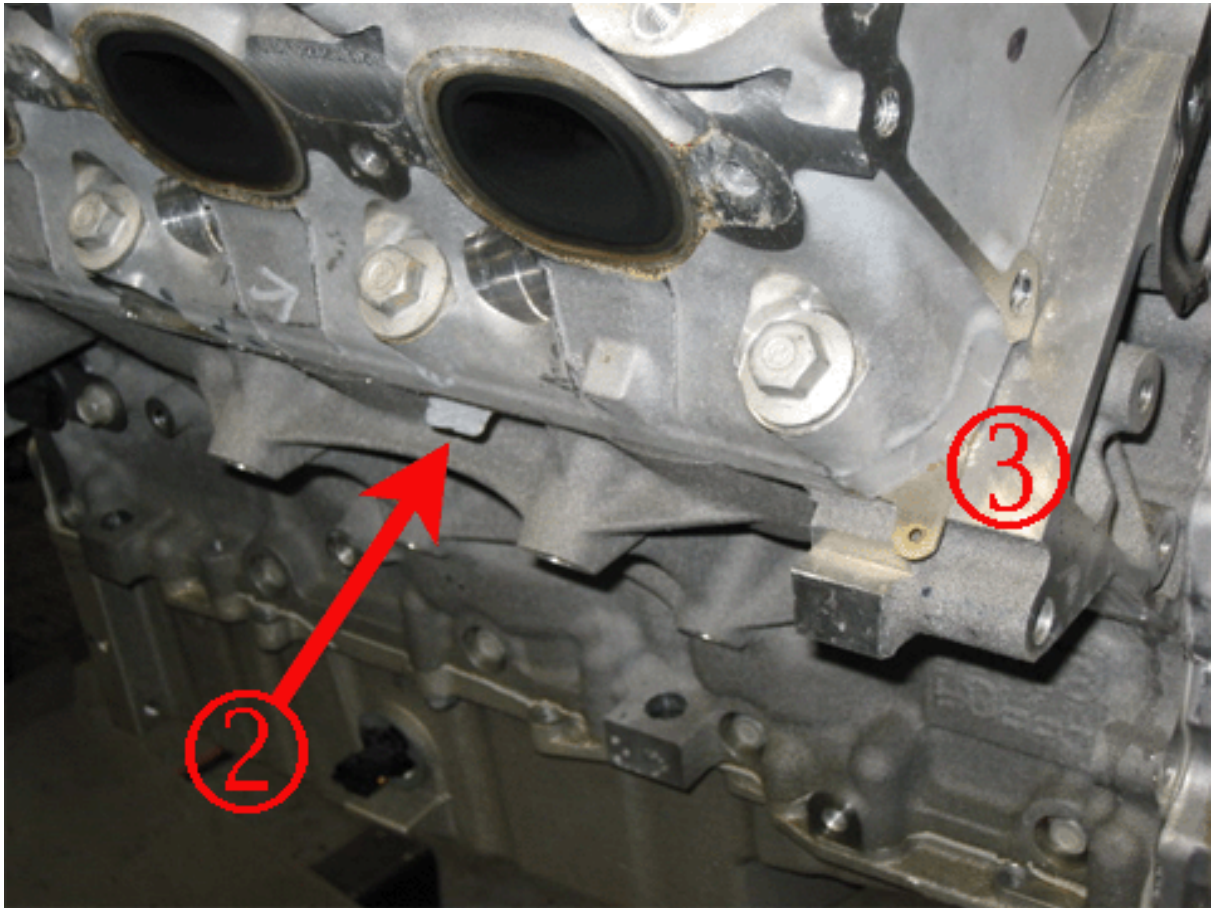
Per the attached pictures, the head gasket locating tabs for both of the engine cylinder banks should be toward the front of the engine.

1. Bank 1 tab near cylinder 3

2. Bank 2 tab near cylinder 4

3. Is the front of the engine

If the head gasket locating tabs are found to be closer to cylinders 5 or 6, this indicates the head gaskets were installed incorrectly restricting the engine coolant flow.

Replace the head gasket to repair for this concern.
