# 2016 - 2019 Cadillac CTS-V: Service Bulletin: #PIP5212C: Concern Of An Engine Thermostat Tick Noise And/Or Running Hot - (Mar 30, 2021)

## #PIP5212C: Concern Of An Engine Thermostat Tick Noise And/Or Running Hot - (Mar 30, 2021)

**Subject:** Concern Of An Engine Thermostat  
Tick Noise And/Or Running Hot

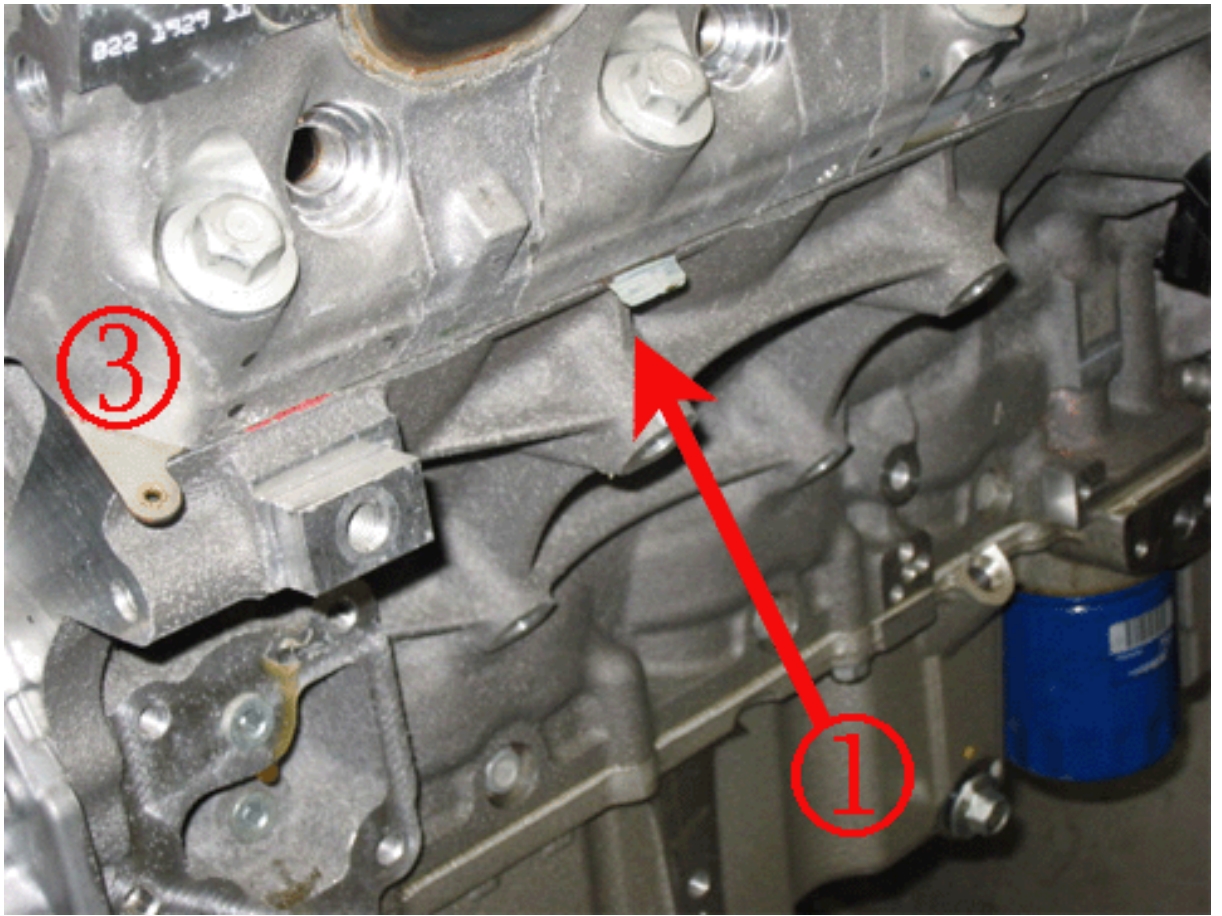
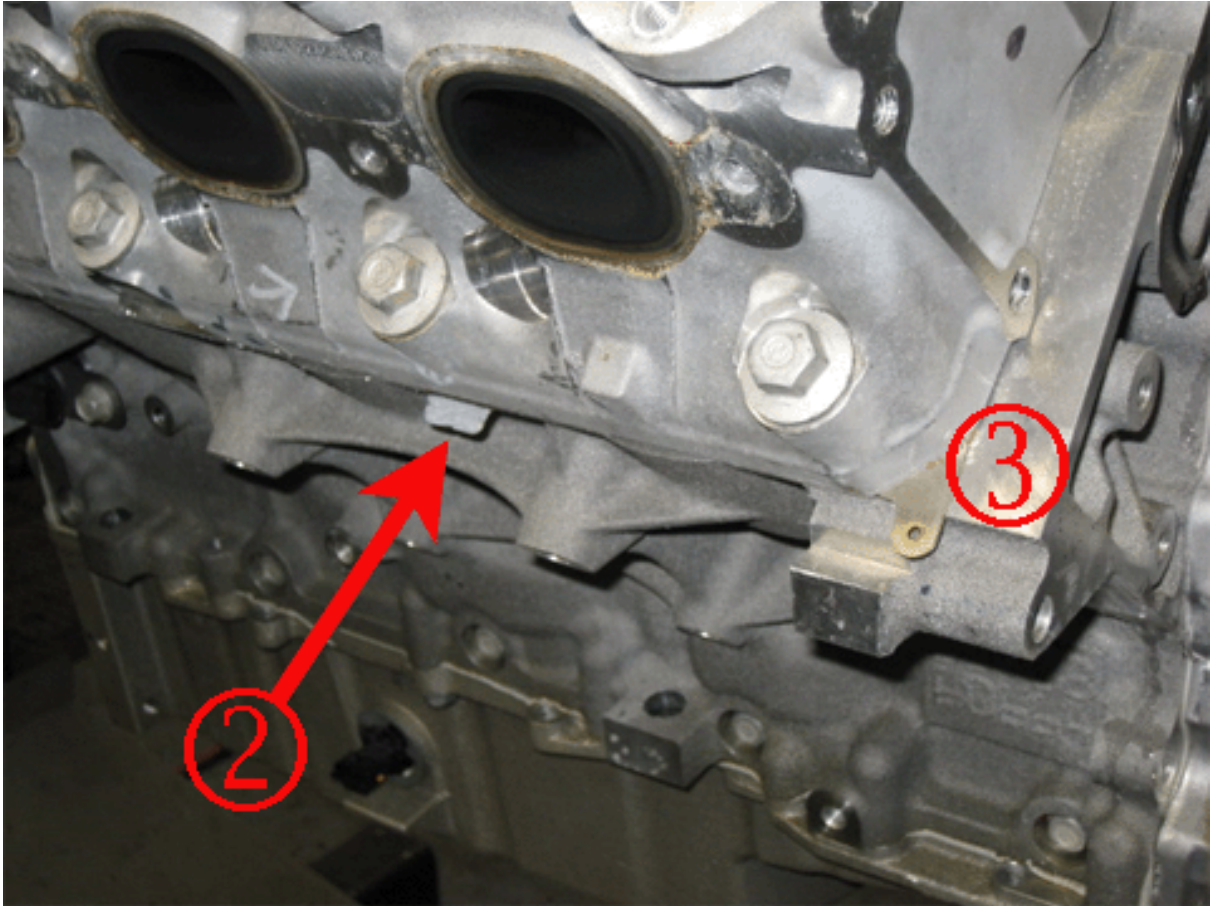
Per the attached pictures, the head gasket locating tabs for both of the engine cylinder banks should be toward the front of the engine.

1. Bank 1 tab near cylinder 3

2. Bank 2 tab near cylinder 4

3. Is the front of the engine

If the head gasket locating tabs are found to be closer to cylinders 5 or 6, this indicates the head gaskets were installed incorrectly restricting the engine coolant flow.

Replace the head gasket to repair for this concern.
