# 2020 - 2021 Cadillac CT4-V CT5-V: Service Bulletin: #21-NA-091: Information on Normal Rearview Camera Display Operation - Flashing Diamond - Spot - or UFO like image on Rear View Camera Display - (Apr 13, 2021)

**Subject:** Information on Normal Rear View Camera Display Operation - Flashing Diamond - Spot - or UFO like image on Rear View Camera Display

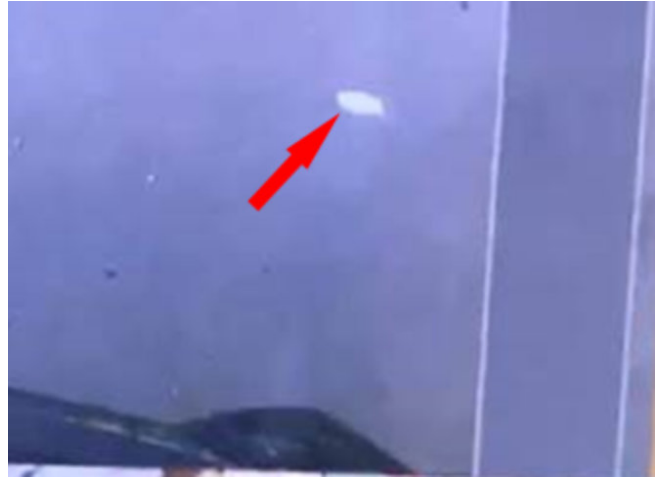
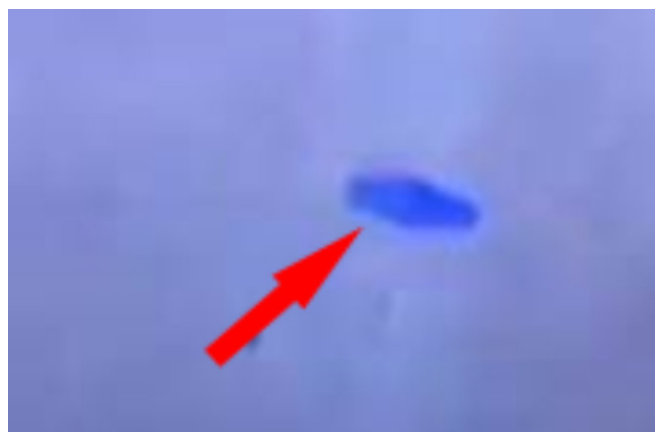
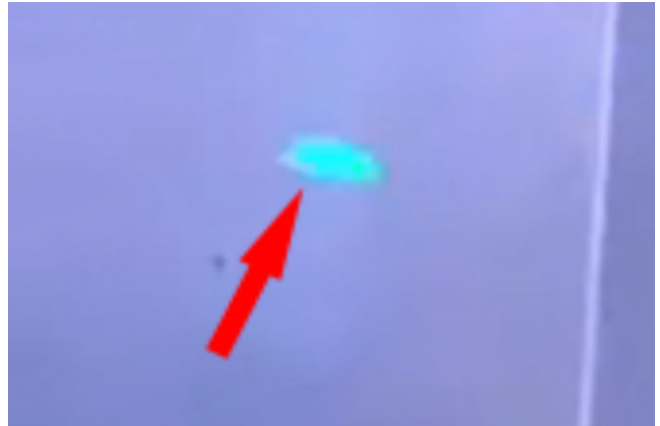
Some customers may comment on a flashing light present on the radio display when in Reverse and with the rear view camera on, usually is

corrected by an ignition cycle.

Please communicate to the customer that the rear view camera system and radio display are functioning as designed and this is a normal condition of their vehicle. Please share this information with the customer, including a copy of this bulletin.

Technicians should verify that no other conditions are present and return the vehicle to the customer.
