2020 - 2021 Cadillac CT4-V CT5-V: Service Bulletin: #21-NA-091: Information on Normal Rearview Camera Display Operation - Flashing Diamond - Spot - or UFO like image on Rear View Camera Display - (Apr 13, 2021)

Information on Normal Rear View Camera Display Operation - Flashing Diamond - Spot - or UFO like image on Rear View Camera Display

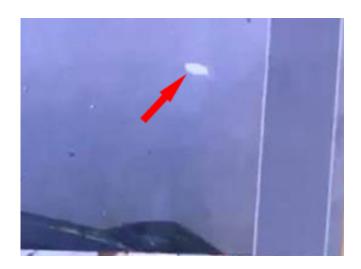
Some customers may comment on a flashing light present on the radio display when in Reverse and with the

rear view camera on, usually is

corrected by an ignition cycle.

Please communicate to the customer that the rear view camera system and radio display are functioning as designed and this is a normal condition of their vehicle. Please share this information with the customer, including a copy of this bulletin.

Technicians should verify that no other conditions are present and return the vehicle to the customer.
