2016 Cadillac ATS-V: GM TechLink: Vehicle Time Out for Parasitic Draw Testing

GM TechLink September 18, 2016

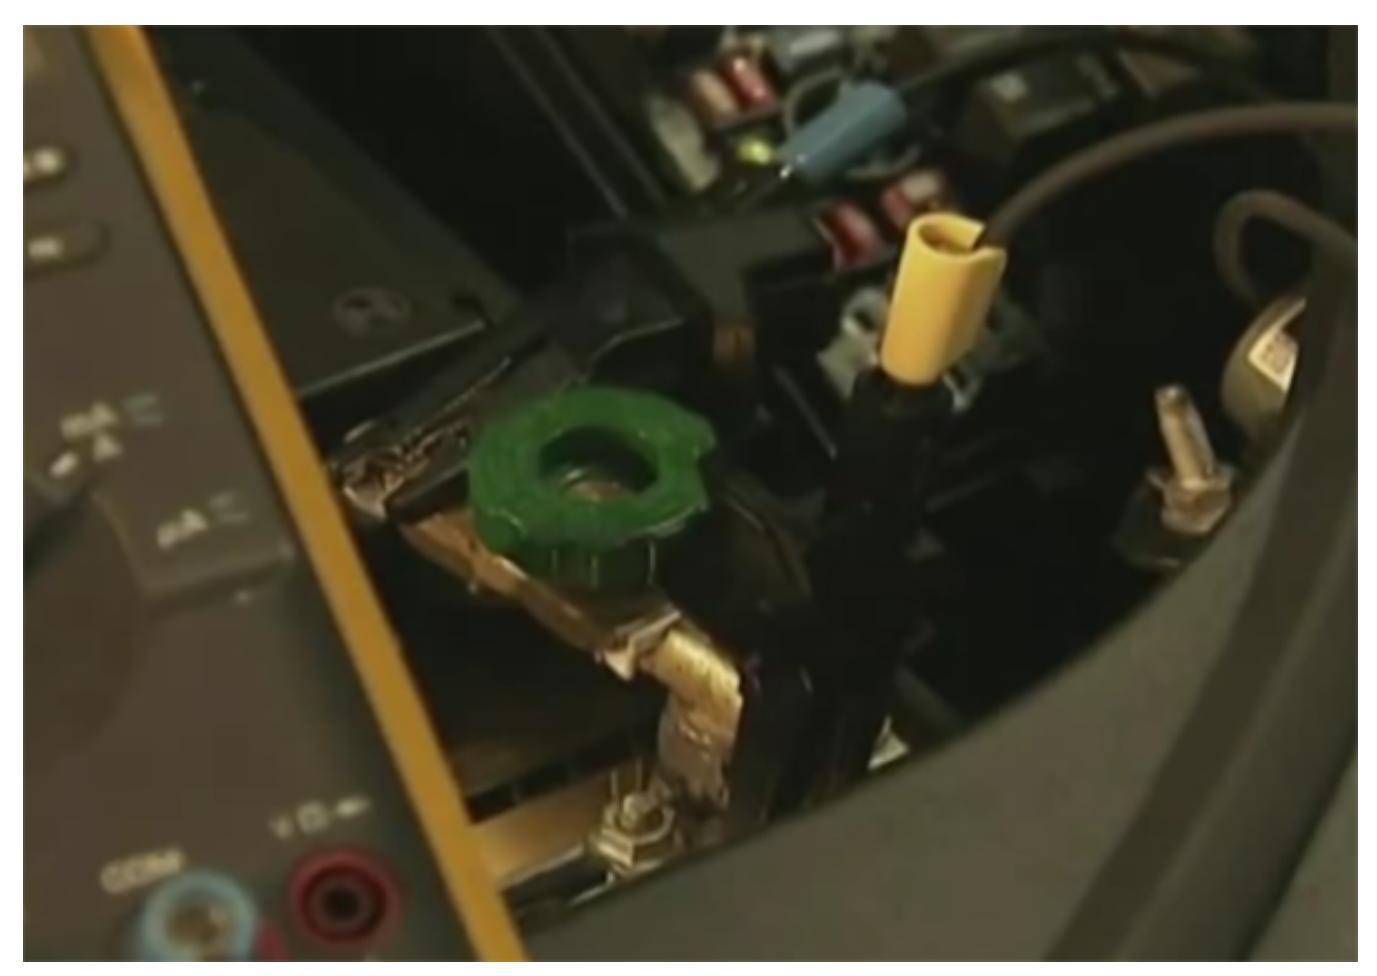
Fig. 27

There are many things that can prevent a vehicle from completely going to sleep and passing the parasitic draw test. Make sure all the following conditions are met before performing the parasitic current draw test using the EL 38758 parasitic draw test switch. (Fig. 27)
