2015 - 2018 Cadillac CTS-V: GM TechLink: Hard Shifting into 1st Gear or Reverse

2015 - 2018 Cadillac CTS-V: Hard Shifting into 1st Gear or Reverse

GM TechLink
June 10, 2017

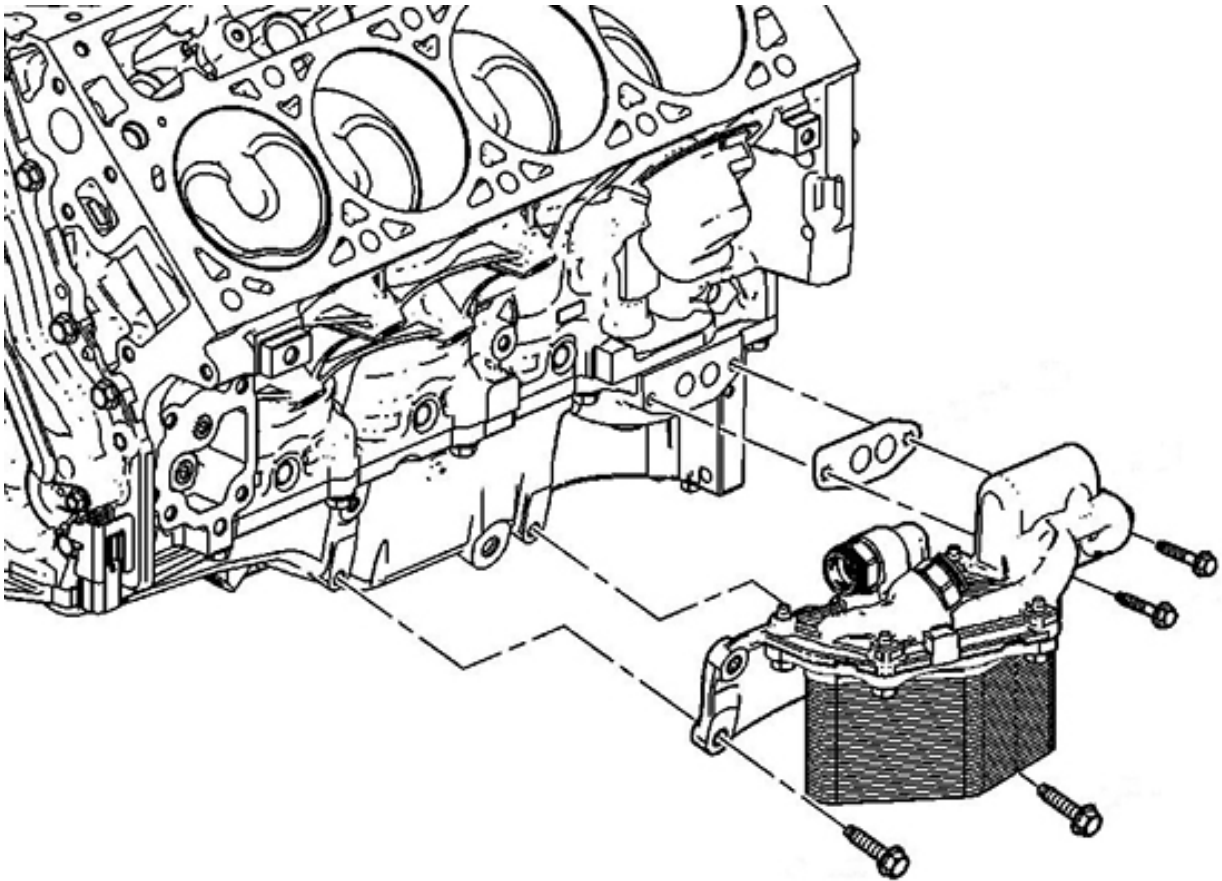
Fig. 11

TIP: On engines with a dry sump oil system, the oil tank and lines, and the oil cooler (if equipped) (Fig. 11), should be replaced when repairing the engine.
