# 2016 - 2017 Cadillac CTS-V: GM TechLink: Fuel Line Pulsation Sound

### GM TechLink

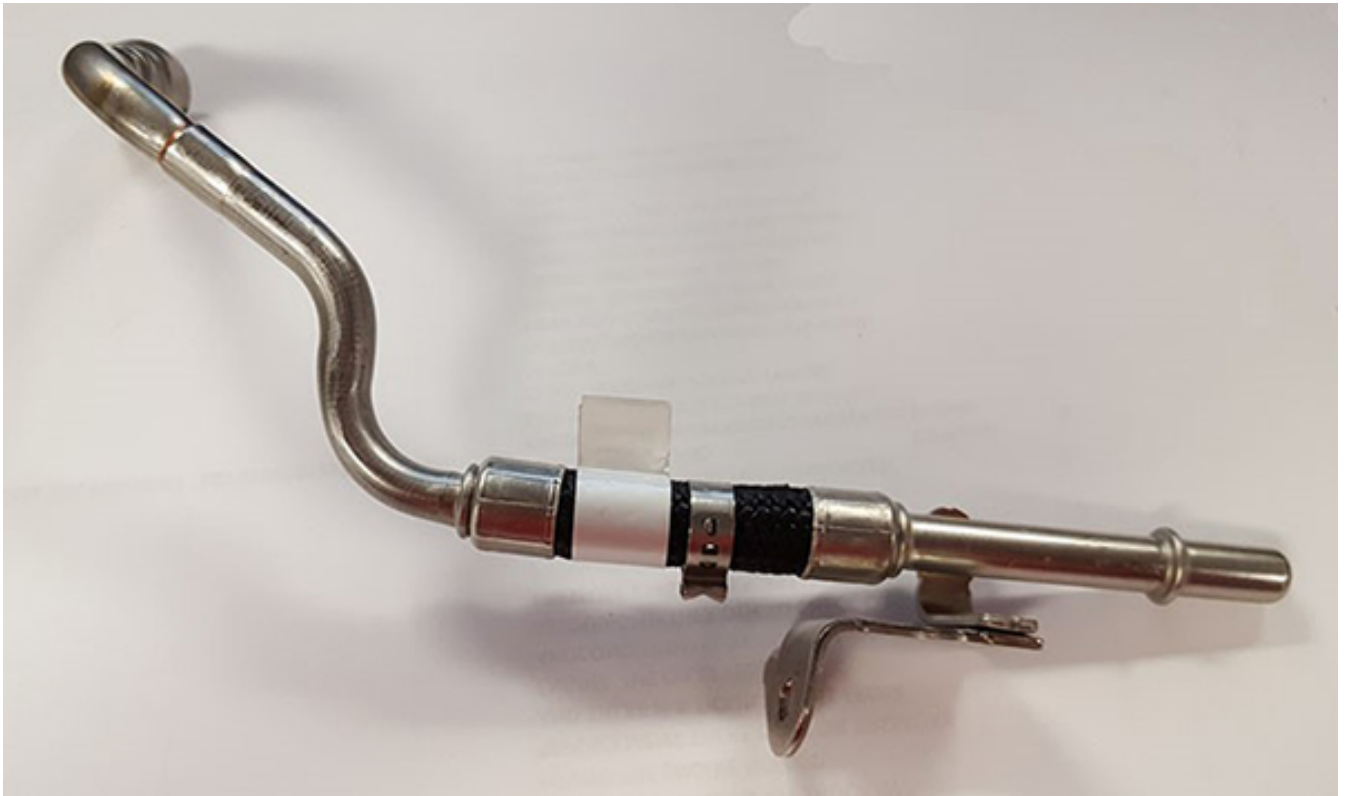
**FIG. 9**

There are two different types of fuel lines that contain a check valve. The lines vary by model. Only one line should be used on Corvette, truck and SUV models. (Fig. 9) The line connects the chassis fuel line to the high pressure fuel pump. (Fig. 10)

Listen to the fuel line connection at the left side of the engine. The fuel feed line between the high pressure fuel pump and chassis fuel line may be allowing high pressure pulsation back to the low side of the fuel system. If the sound is heard, the line will need to be replaced. On some trucks and SUVs, a vibration also may be observed in the fuel line at the fuel tank.
