# 2016 - 2018 Cadillac ATS-V CTS-V: Service Bulletin: #16-NA-059: Staining/Discoloring to Brake Caliper Paint - (Oct 14, 2020)

**Subject:** Staining/Discoloring to Brake Caliper Paint

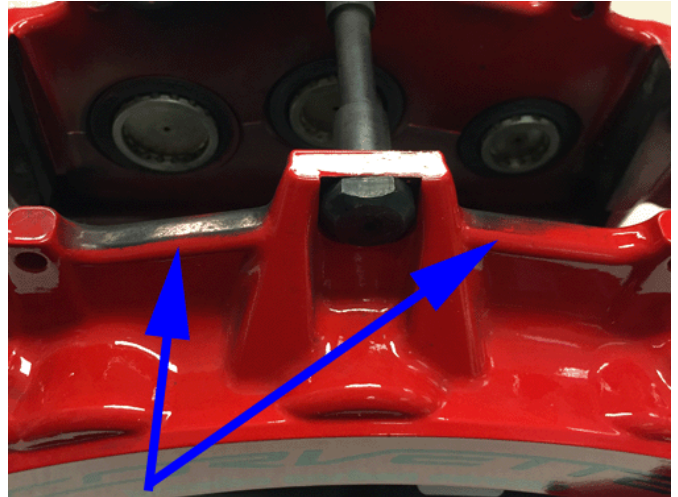
Some customers may comment on a discoloration or black stain on the paint of the brake calipers. This may be caused by high brake pad temperatures during aggressive driving or track event tarnishing the caliper paint.

**Important:** Do *NOT* replace the brake calipers for this condition.

This is not a defect in the paint or the caliper.

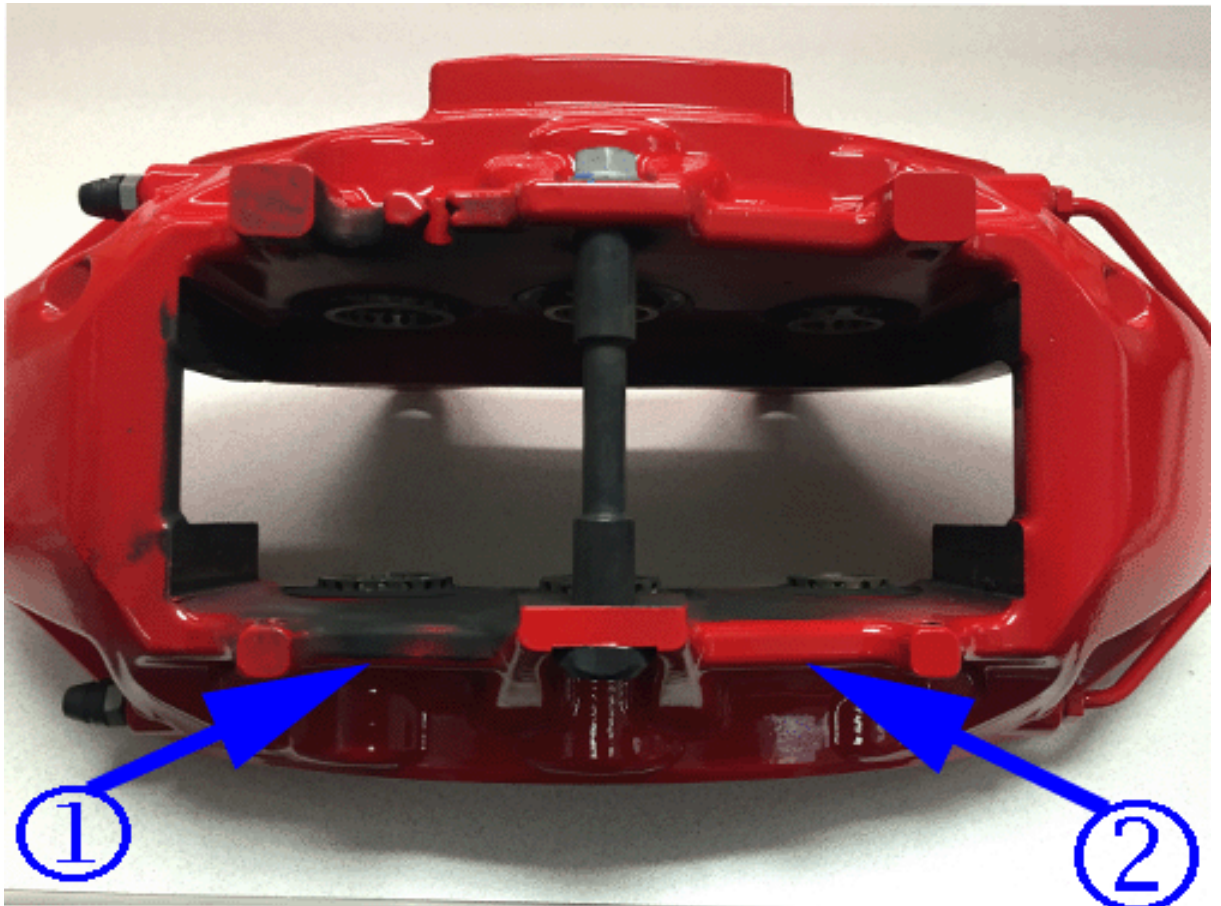
| (1) | Not cleaned using mild polishing compound |
| (2) | Cleaned using mild polishing compound |

If the customer wishes to have the black stain removed, a very mild polishing compound can be used to remove the stain.

**Important:** Do NOT use harsh chemicals or brake cleaner to attempt

to remove the stain. This could damage the paint on the caliper.
