2019 - 2021 Cadillac CT4-V CT5-V CT6-V: Service Bulletin: #PIP5712A: Diagnostic Tip - Crankshaft Balancer Removal - (Mar 9, 2021)

Subject: Diagnostic Tip - Crankshaft Balancer Removal

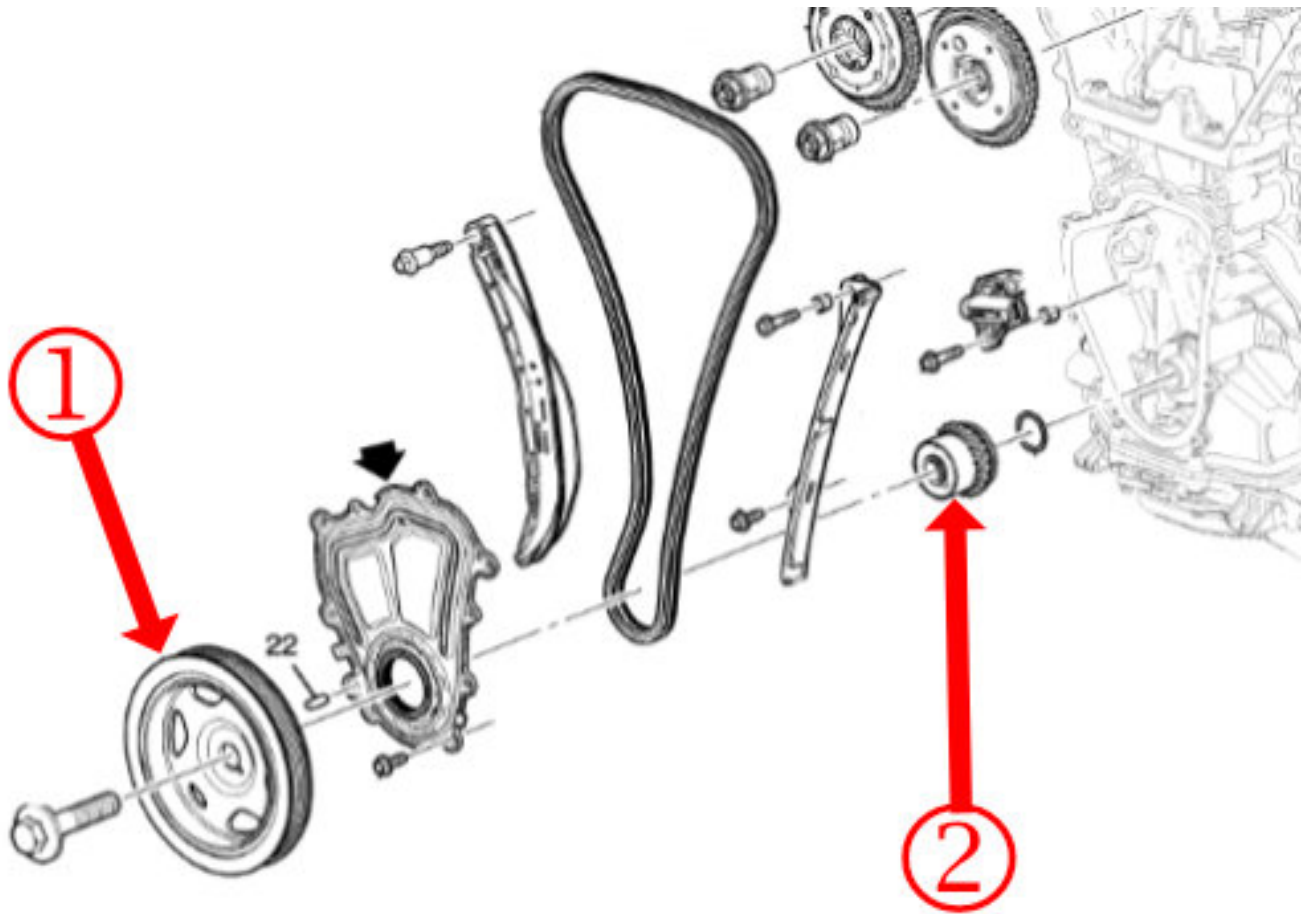
Crankshaft sprocket may disengage from crankshaft during Crankshaft Balancer removal.

Crankshaft sprocket may stick to the Crankshaft balancer during removal.

Anytime that the crankshaft balancer (1) is removed for service, be careful not to pull the crankshaft sprocket (2) off of the end of the crankshaft due to the balancer sticking to the sprocket.

Loosen the crankshaft balancer bolt a few turns and then strike the crankshaft balancer with a rubber mallet to separate the crankshaft balancer from the Crankshaft sprocket.

Caution: Do not rotate the crankshaft on these engines with the crankshaft balancer removed. The crankshaft balancer and bolt must be reinstalled to avoid damage to the crankshaft sprocket, crankshaft and valvetrain.

Once the two components are separated, proceed with repair / diagnosis.
